Survey Excavation in the Granite Room of the Suffolk Resolves House, May 19, 2012

Objective: To determine if a pre-20th century occupation floor remained.

Conclusion: No occupation floor predating the 20th century remains. The floor appears to have been excavated down to bedrock by William Morris Hunt II and his crew in 1950.

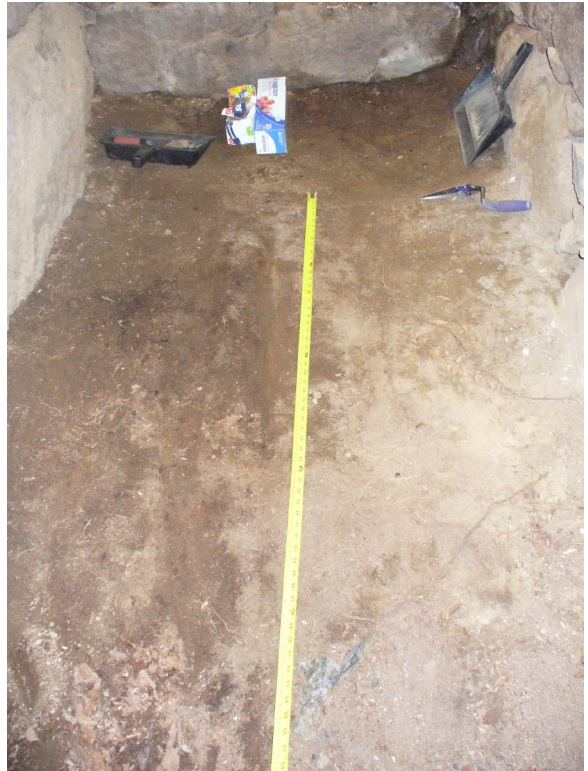
Level 1: About an inch of loose, brown silt densely littered with 19th- and early 20th-century artifacts. This date range was determined by a daguerrotype case fragment with the manufacturer's label still readable, and an ink stamp of the Milton Historical Society (founded 1904). A number of ambrotypes were found, too, one with the subject's added rouge still perfectly intact. Door hardware seemed the dominant category, but the collection was diverse. The largest artifacts included a rusted remnant of a wide head of an hoe- or adze-like implement and a rusted bayonet with what appears to be a 20th-century hose-clamp wrapped around its base. Remains of cardboard boxes were plentiful, often penetrated by thin, wispy roots coming up from Level 2. A few small, late 20th-century artifacts were found, such as fragments of plastic-insulated electrical wiring (the room was first wired for electricity in the early 1950's) and a red plastic LEGO brick. These may have been co-deposited with the older artifacts and/or penetrated from the surface.

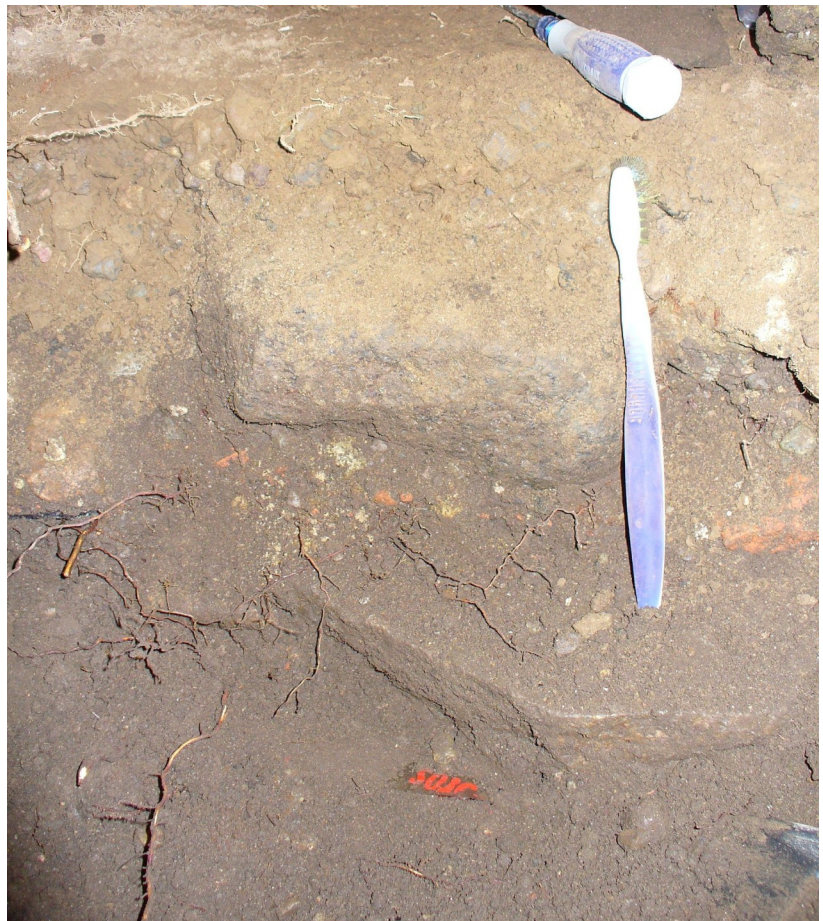
Level 4: About 3 inches of organic soil horizon penetrated with healthy tree

roots up to a half-inch in diameter. Artifacts were small and scarce, comprising rusted nails of square cross-section, bits of tarpaper-asphalt shingles, and one rim-fragment of a large terra-cotta pot. The photo below shows the base of this level.

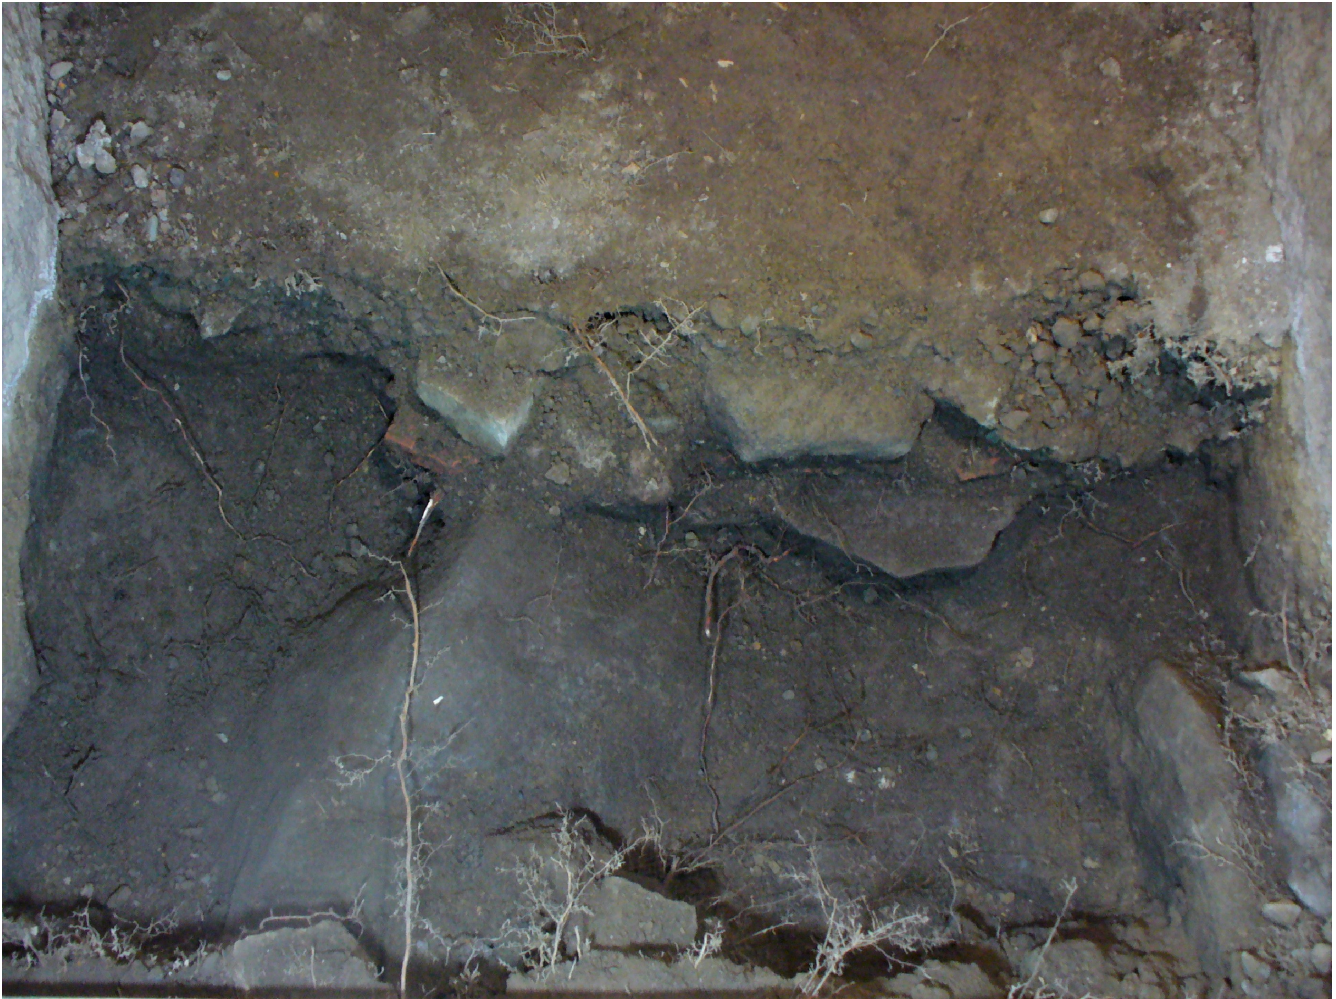
Level 5: Varying in depth due to the protruding bedrock, this layer comprised broken pieces of granite mixed with smooth rocks varying in size, in a thin matrix of yellow silt. No artifacts.

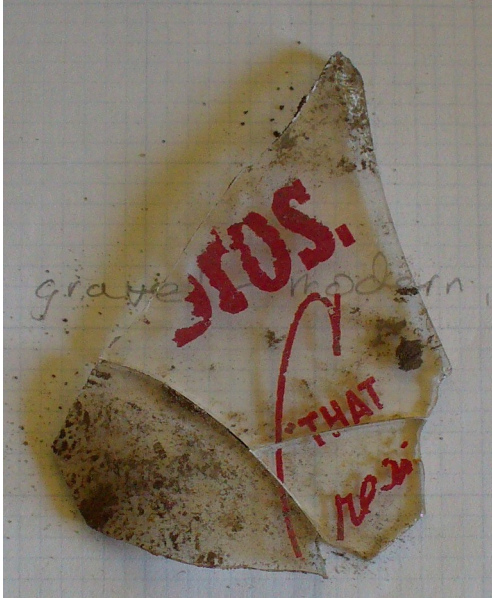
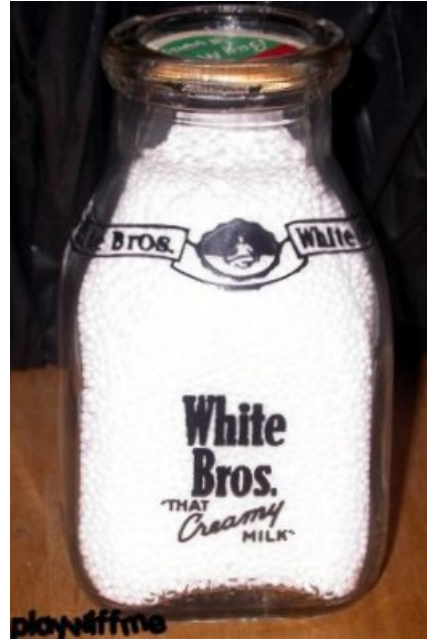
Level 3: 6 inches of dense, evenly sorted gravel, probably of modern manufacture, with large rocks and a few brick fragments mixed in. The matrix is a yellow silty clay. Artifacts were scarce and small: nails or screws rusted beyond identification, fragments of tarpaper-asphalt shingles, aluminum foil, and near the top of the layer a glazed, ceramic fragment, painted yellow with tiny white and blue flowers. Near the bottom of the level a piece of glass labeled in red was found (*in situ* at right), roughly 2 by 3 inches, subsequently identified as part of a milk bottle from the White Brothers Dairy, founded 1913.

the parlor, via a stairway and trap door cut into the 18th-century floor, indicate the room was intended for public viewing. The addition of electrical lighting in an antique or replica fixture corroborates this. The milk bottle fragment, combined with asphalt shingles (on the house when it came to the site and after renovation) provides crucial dating. Hunt believed at least a century of vegetation covered the room in 1950, so the post-1913 milk bottle likely did not arrive before 1950. The bottle fragment is pictured below on eighth-inch graph paper, with a similarly labeled bottle at right, for sale online.

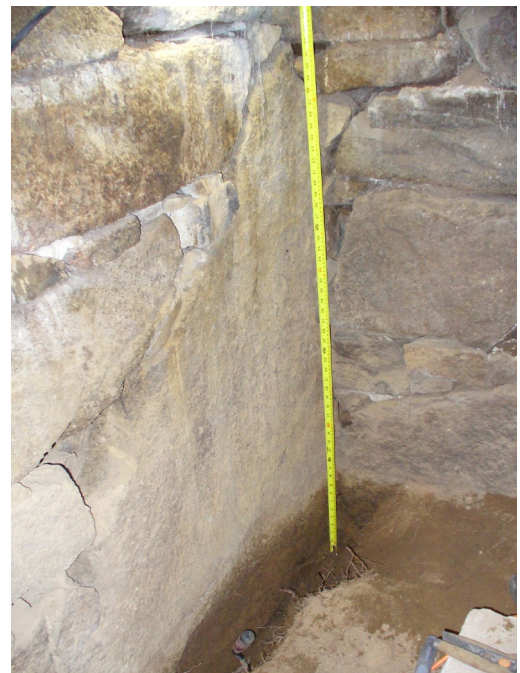
Finally, a small excavation in the northern corner of the room was made to search for quarry marks at the bottom of a nearly 4-foot square slab of smoothed granite. No marks were found, and the sediment there was mostly sterile sand from the foundation of the nearby concrete footing. The quarry marks in the ceiling slabs suggest the ceiling of the room, at least, was built no earlier than 1803 (see *The Art of Splitting Stone: Early Rock Quarrying Methods in Pre-industrial New England 1630-1825*, by Mary Gage. Amesbury, MA: Powwow River Books, 2005).
